**Flood Control Project Maintenance  
Levee Inspections**  
**LMA District Cover Sheet**  
**Spring 2008 Levee Inspection Results**

**Reclamation District No. 0900**

**Flood Control Project Maintenance  
Levee Inspections  
Unit Cover Sheet  
Spring 2008 Levee Inspection Results  
Reclamation District No. 0900**

**Levee Inspection Report By Mile - Spring 2008**

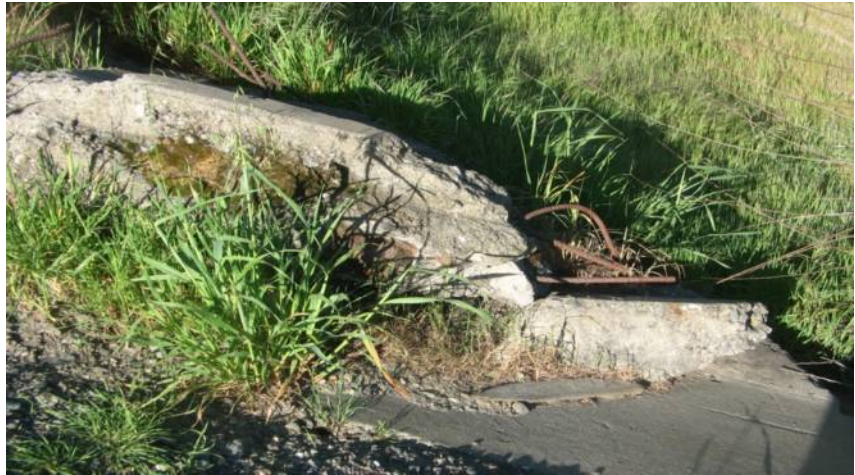
Levee Mile Report Line	18
Start Levee Mile	4.11
End Levee Mile	4.11
Location	
Category	Earthen Levee
Item	Encroachments
Concrete rubble with rebar on landside slope at LM 4.11

17	4.07	4.08	Earthen Levee	Trim / Thin Trees	WS	M	Trim trees to at least five feet above ground level.	38.534678 ° -121.525180 °	38.534580 ° -121.525438 °		17
18	4.11	4.11	Earthen Levee	Encroachments	LS	M	Material Inspector Comments: Concrete rubble with rebar should be removed	38.534402 ° -121.525898 °	38.534402 ° -121.525898 °	Y	18
19	4.15	4.24	Earthen Levee	Trim / Thin Trees	LS	M	Trim trees to at least five feet above ground level.	38.534167 ° -121.526470 °	38.533582 ° -121.527960 °		19

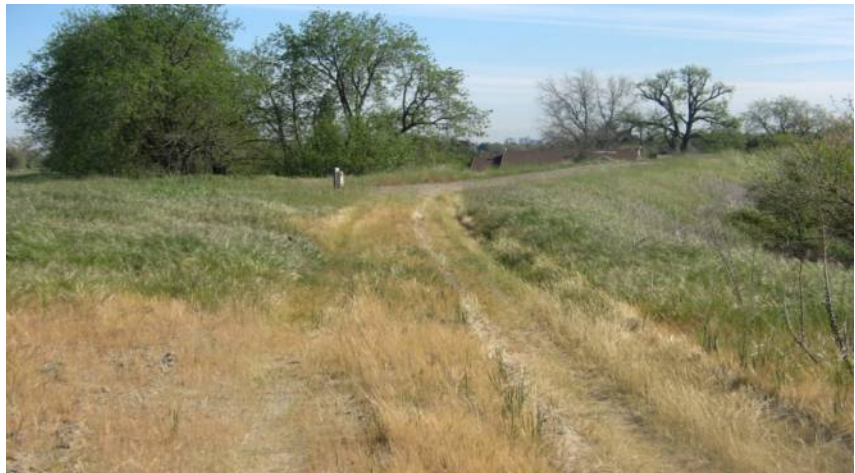
Levee Mile Report Line	33
Start Levee Mile	7.01
End Levee Mile	7.83
Location	
Category	Earthen Levee
Item	Crown Surface / Depressions / Rutting
Crown of levee covered with vegetation from LM 7.00 to 7.83

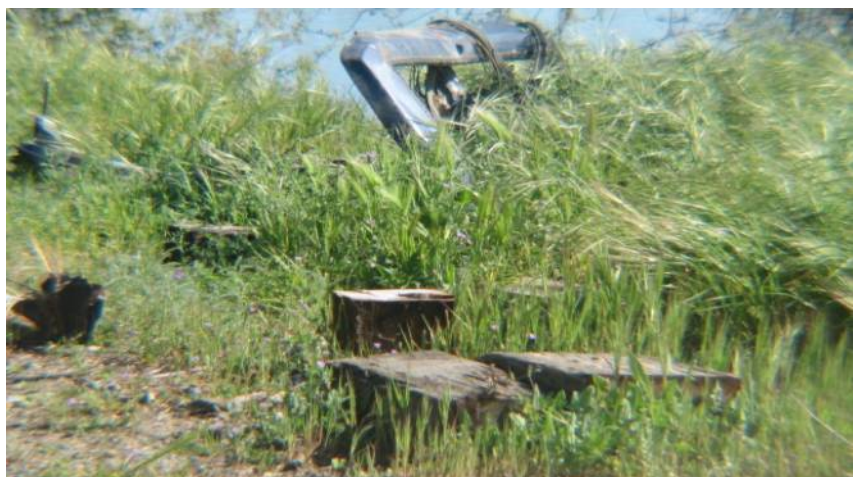
Levee Mile Report Line	44
Start Levee Mile	7.76
End Levee Mile	7.76
Location	
Category	Earthen Levee
Item	Encroachments
Garbage on waterside shoulder at LM 7.76
